# Kirkstall Forge - Paving the Way for a new urban regeneration project in Leeds

# Presentation Summary

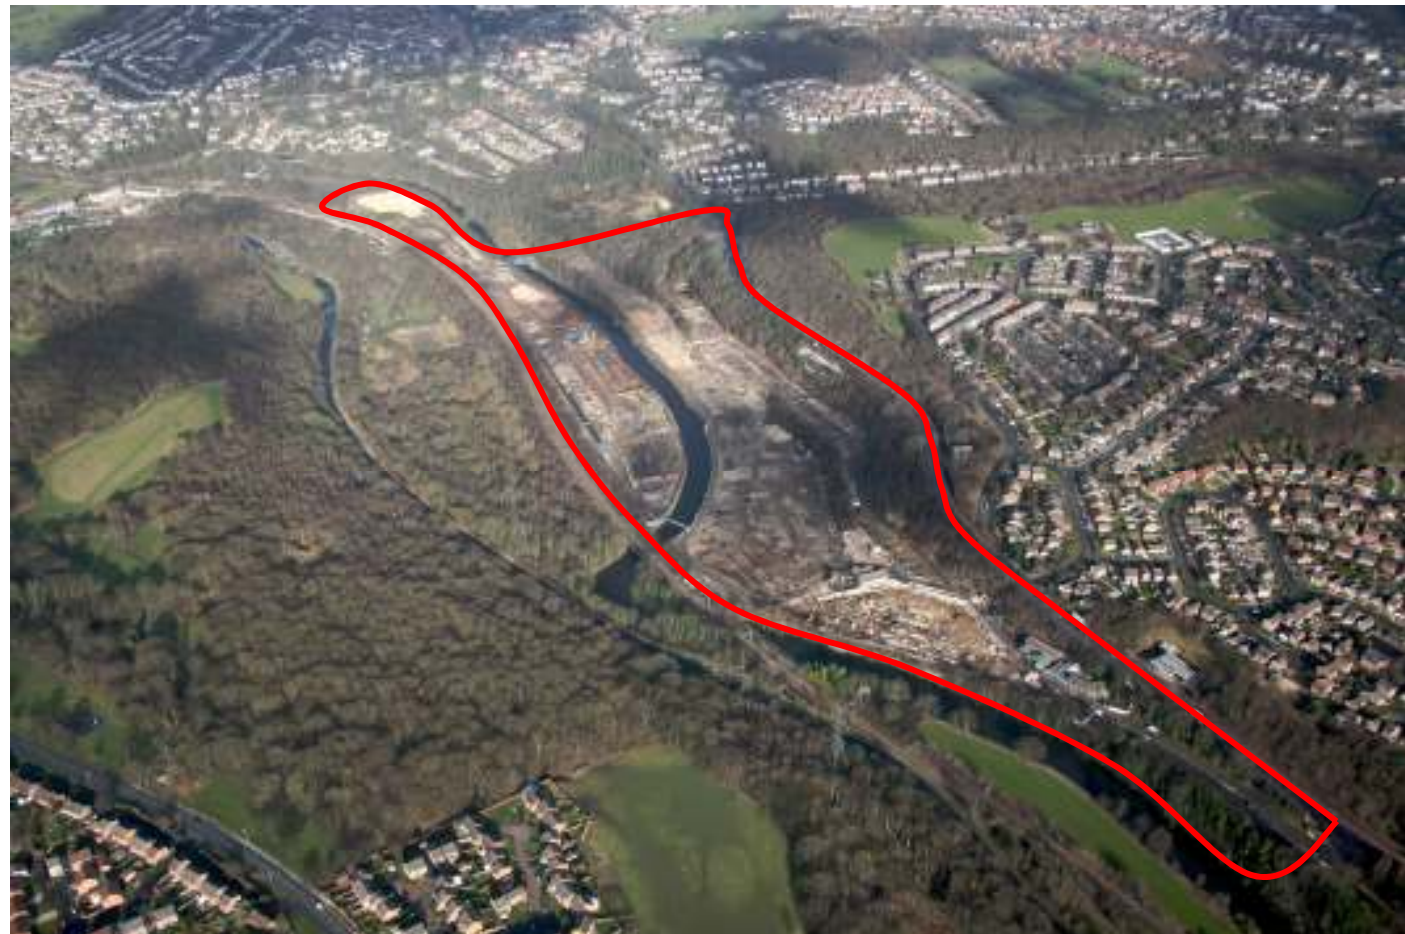
# Location and Setting

- 2.5km north west of Leeds city centre
- South of the A65 Abbey Road, Kirkstall
- River Aire
- Railway
- Canal

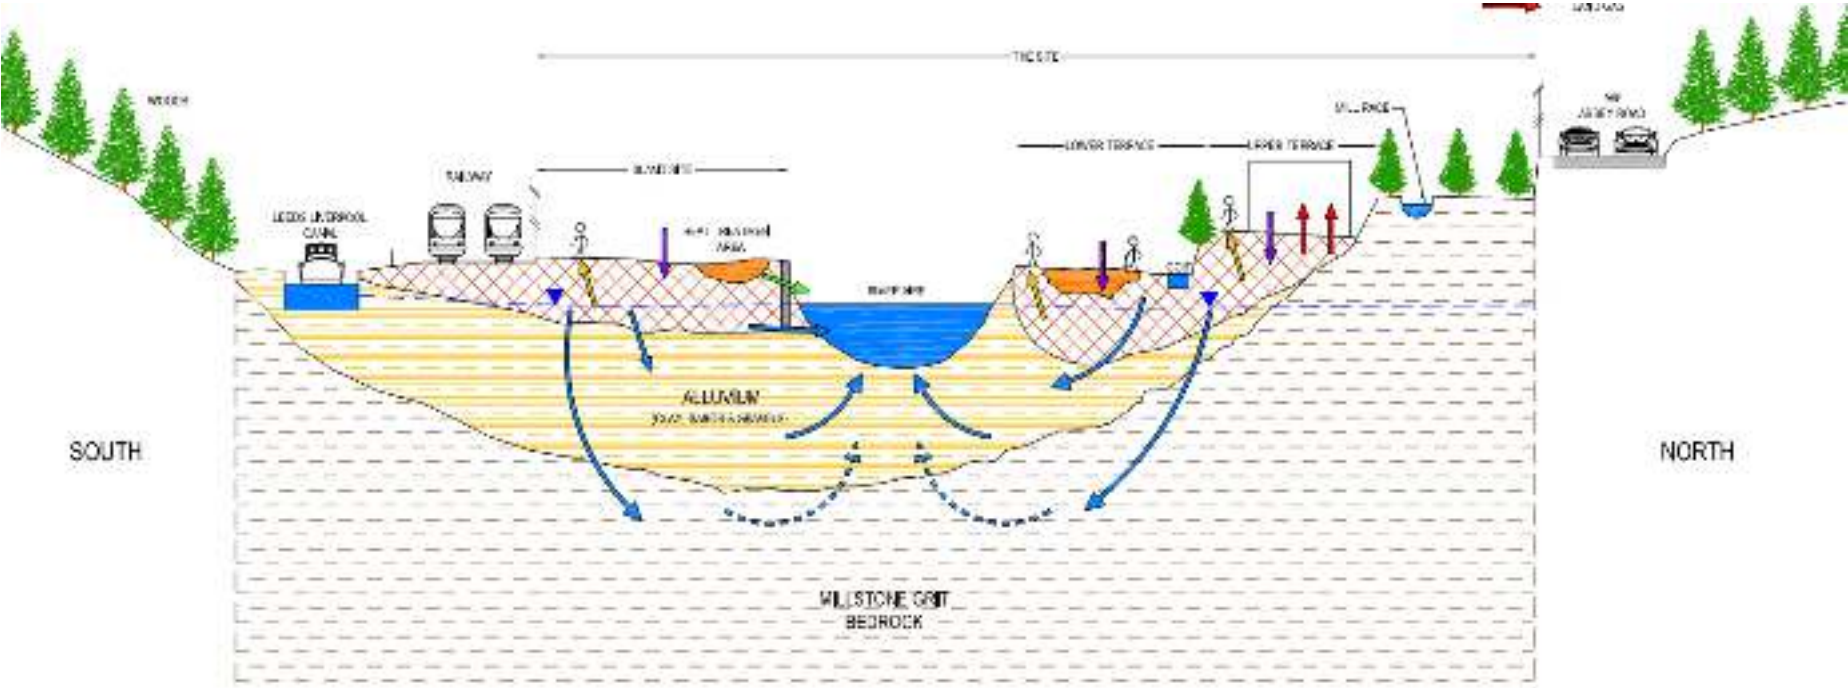
# Geology, hydrology & hydrogeology

- Made Ground
- Alluvium
- Millstone Grit bedrock
- Groundwater / flooding

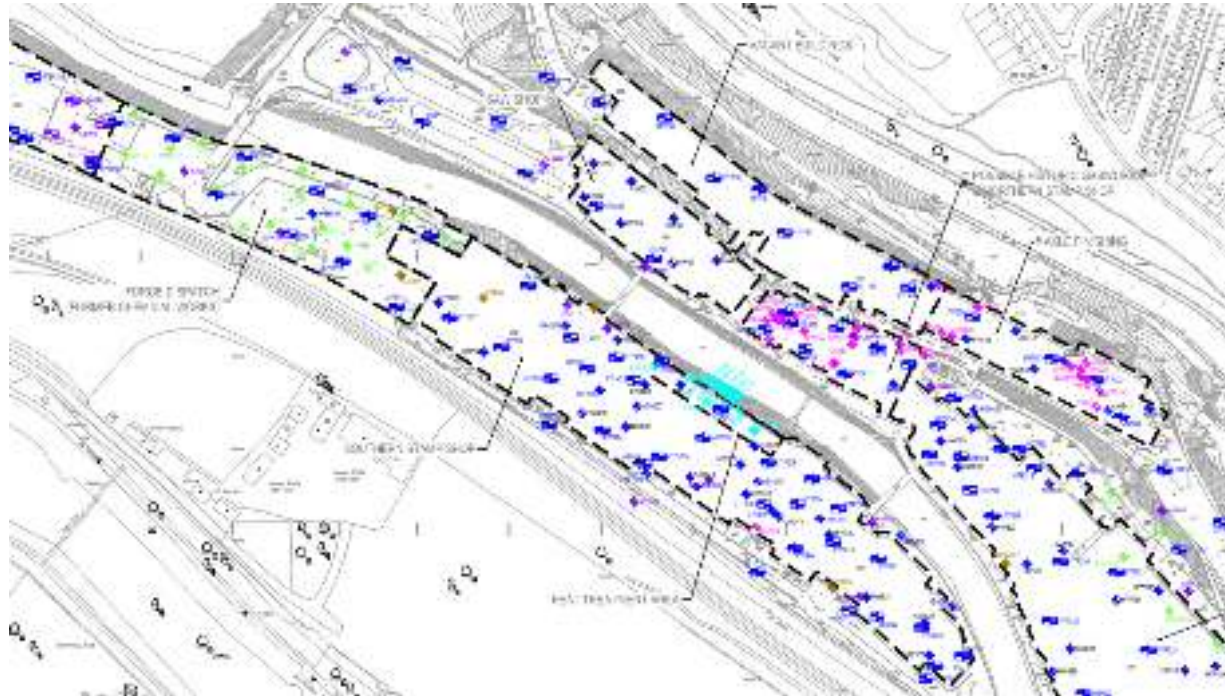
# Ground Investigations

- Prior to 2008 – Several phases of Environmental Ground Investigation
- 2008 to present – WYG Geotechnical and Environmental Investigation
  - Deeper boreholes
  - Groundwater installations
  - Geotechnical testing and sampling

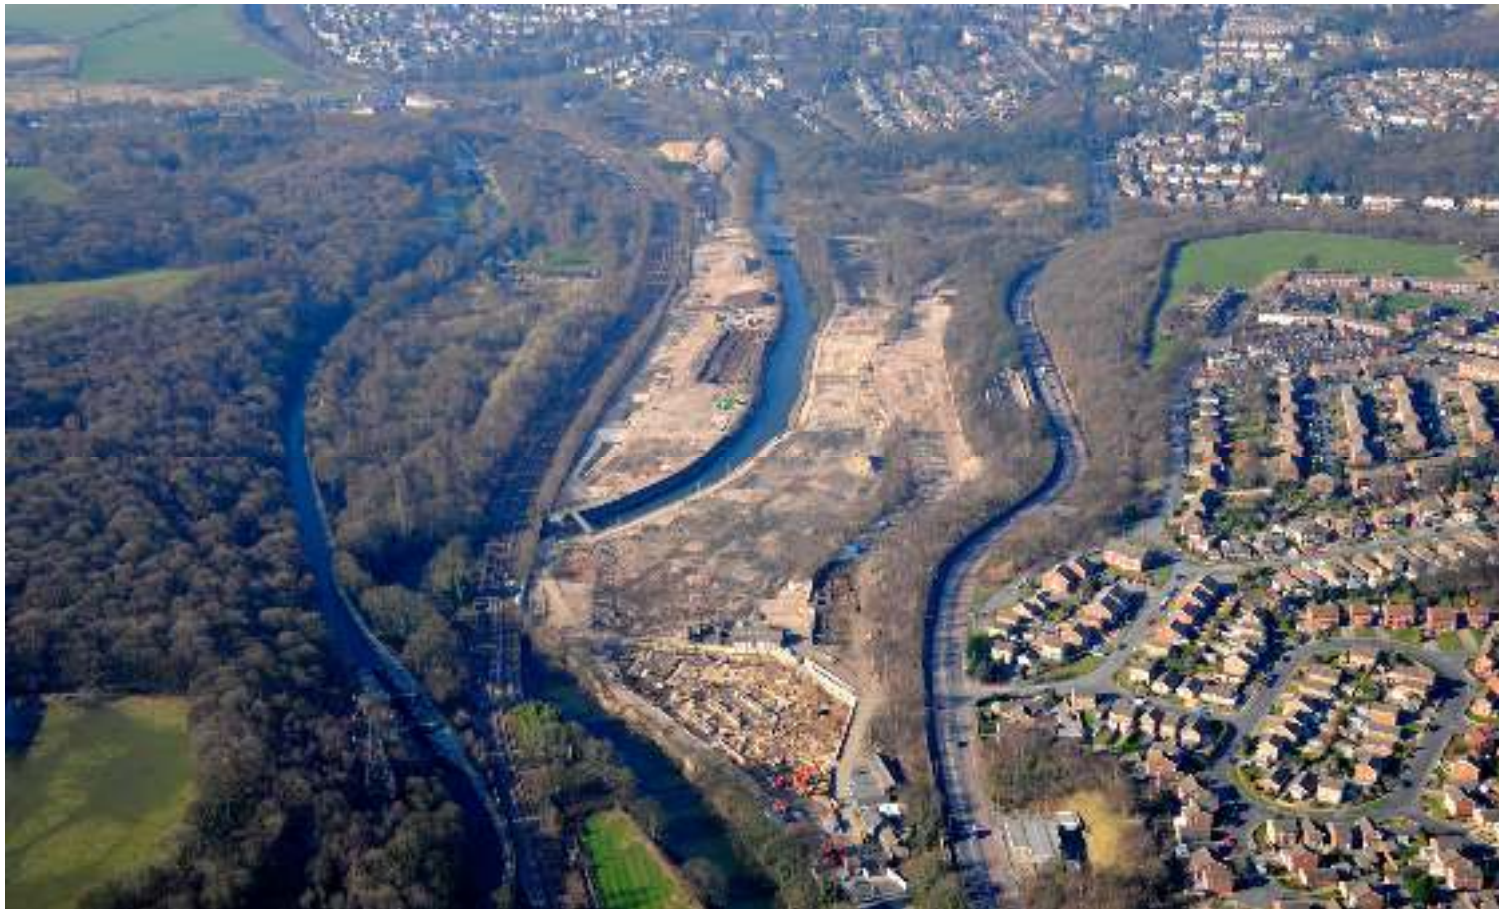
# Redevelopment

- 2008- Demolition / archaeology / early remediation
- 2014 – Phase 1 Infrastructure

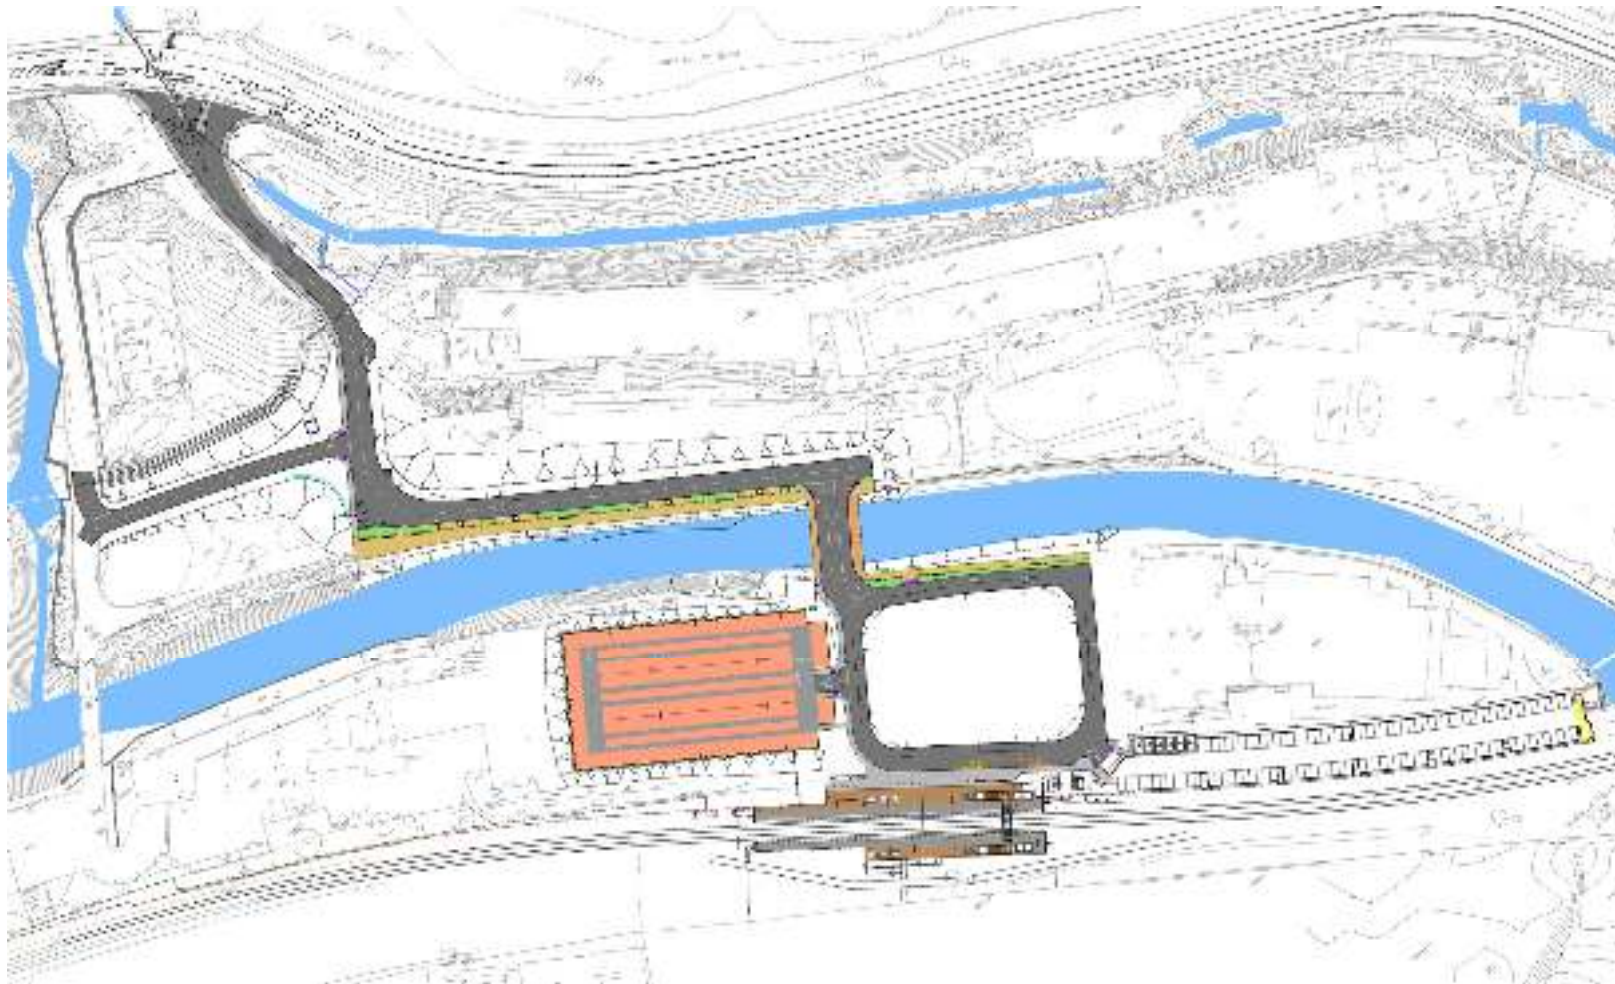
# Phase 1 infrastructure

- 2014 - 2016- Construction

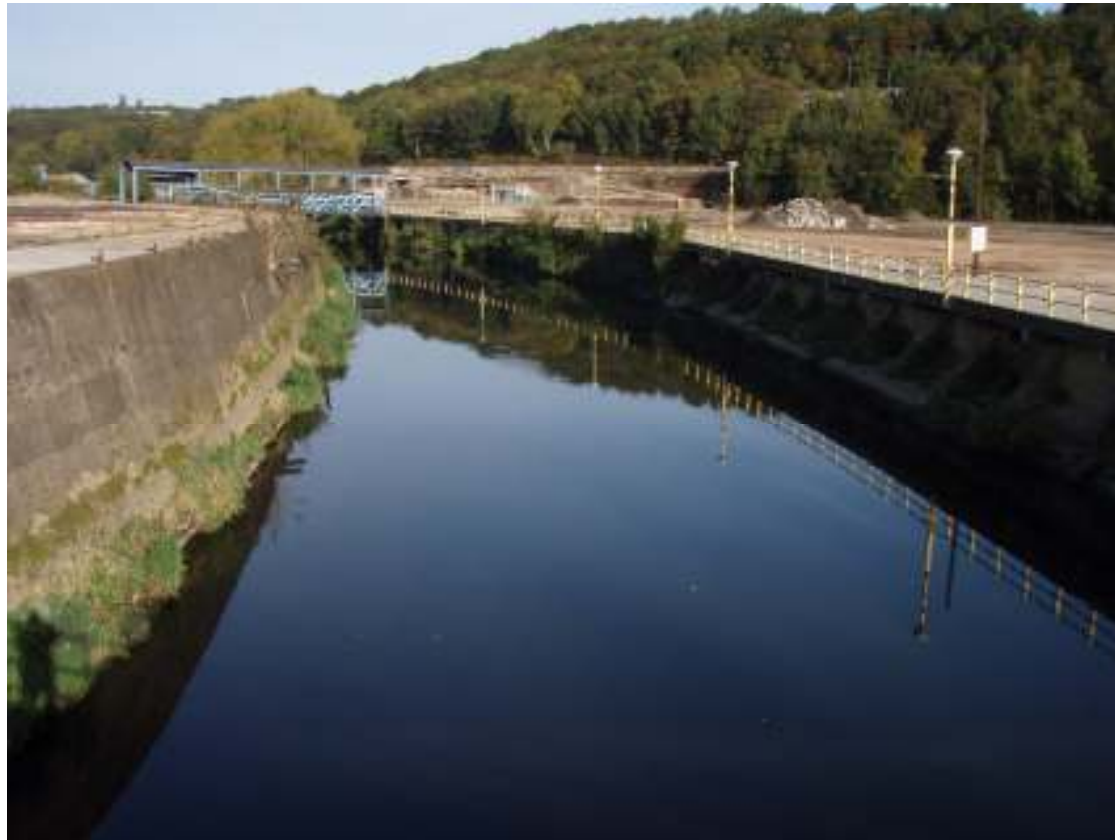
# Geotechnical Challenges

- Raising site levels up to 5m
- Retained heights up to 10m
- Foundations for an 18m wide 30m span bridge
- Foundations for two cantilever pedestrian platforms
- River environment
- Obstructions
- Variable Made Ground

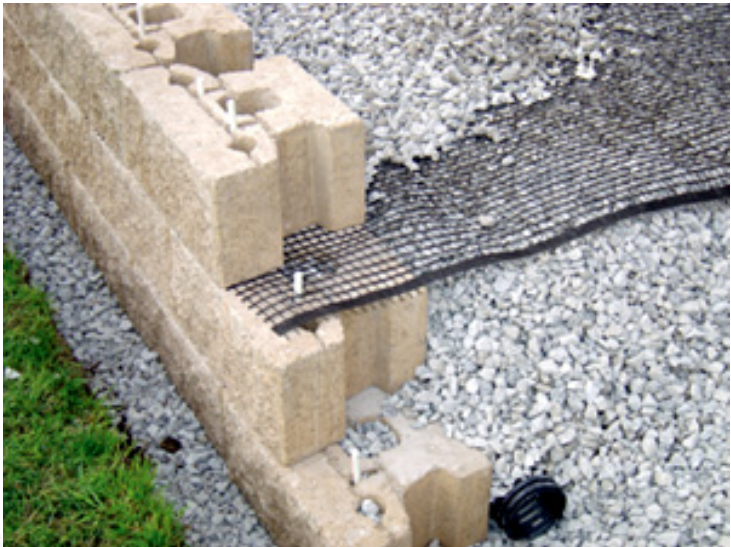
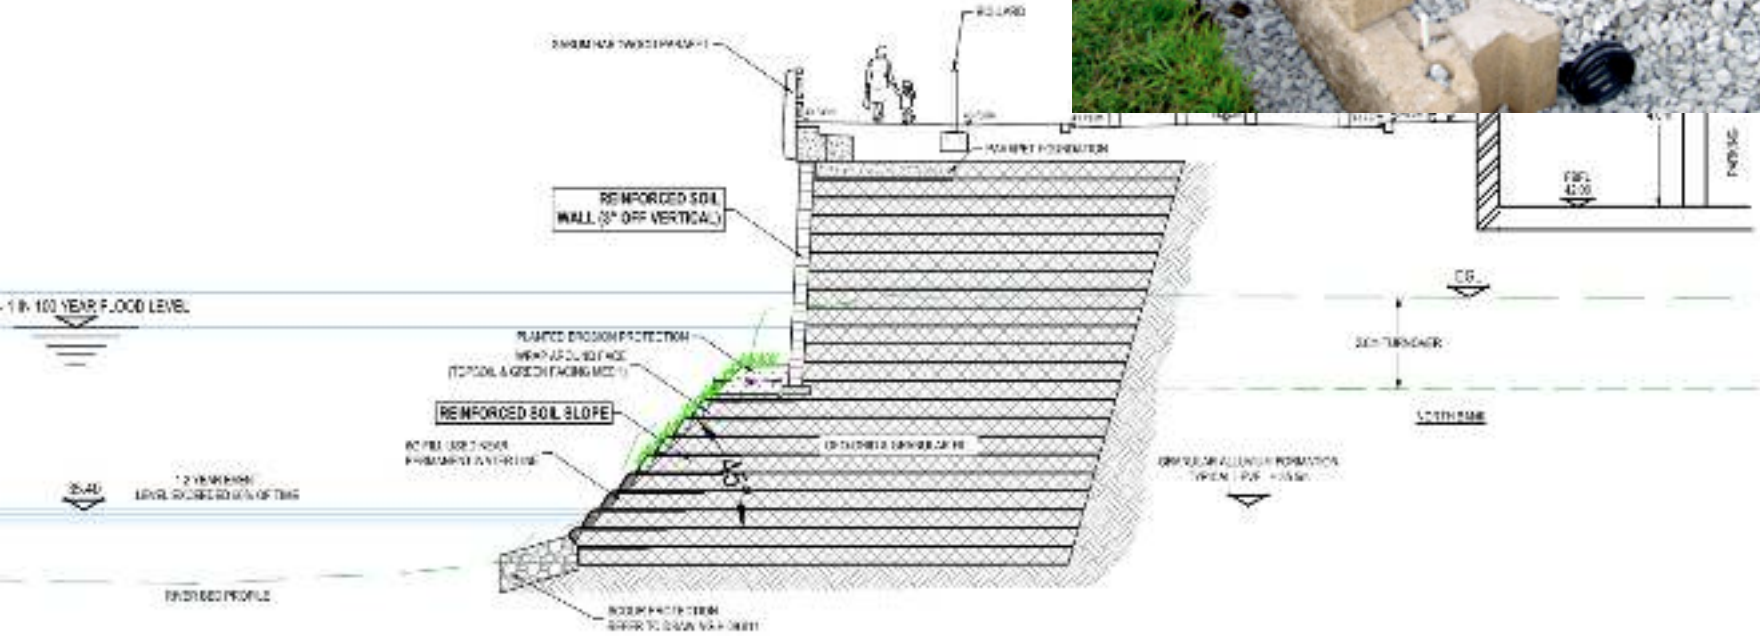
# Geotechnical Challenges

- Reinforced soil and wall solution
  - Re-use of site won materials
  - Allowed founding of bridge bank seats and platforms
  - Provided natural finish

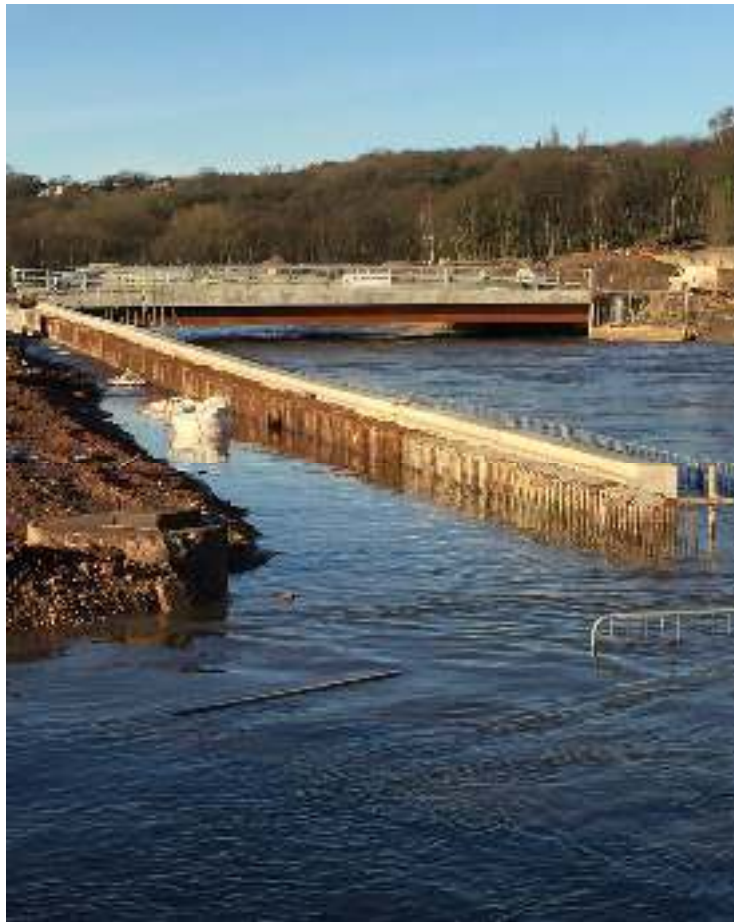
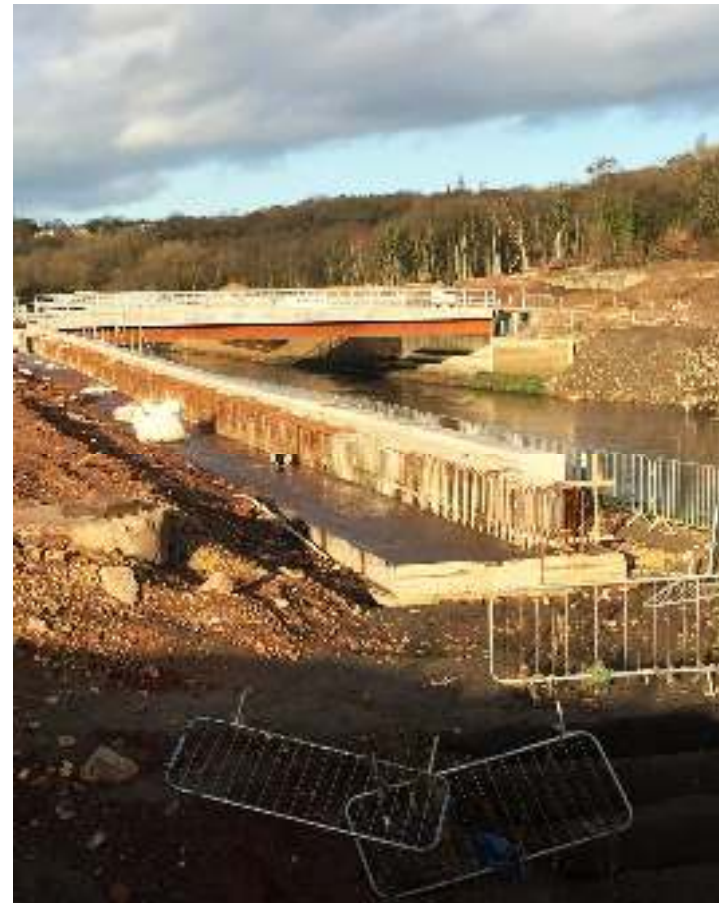
# Geotechnical Challenges

- Winter 2015 – worst flood on record
- Flood levels in line with those predicted

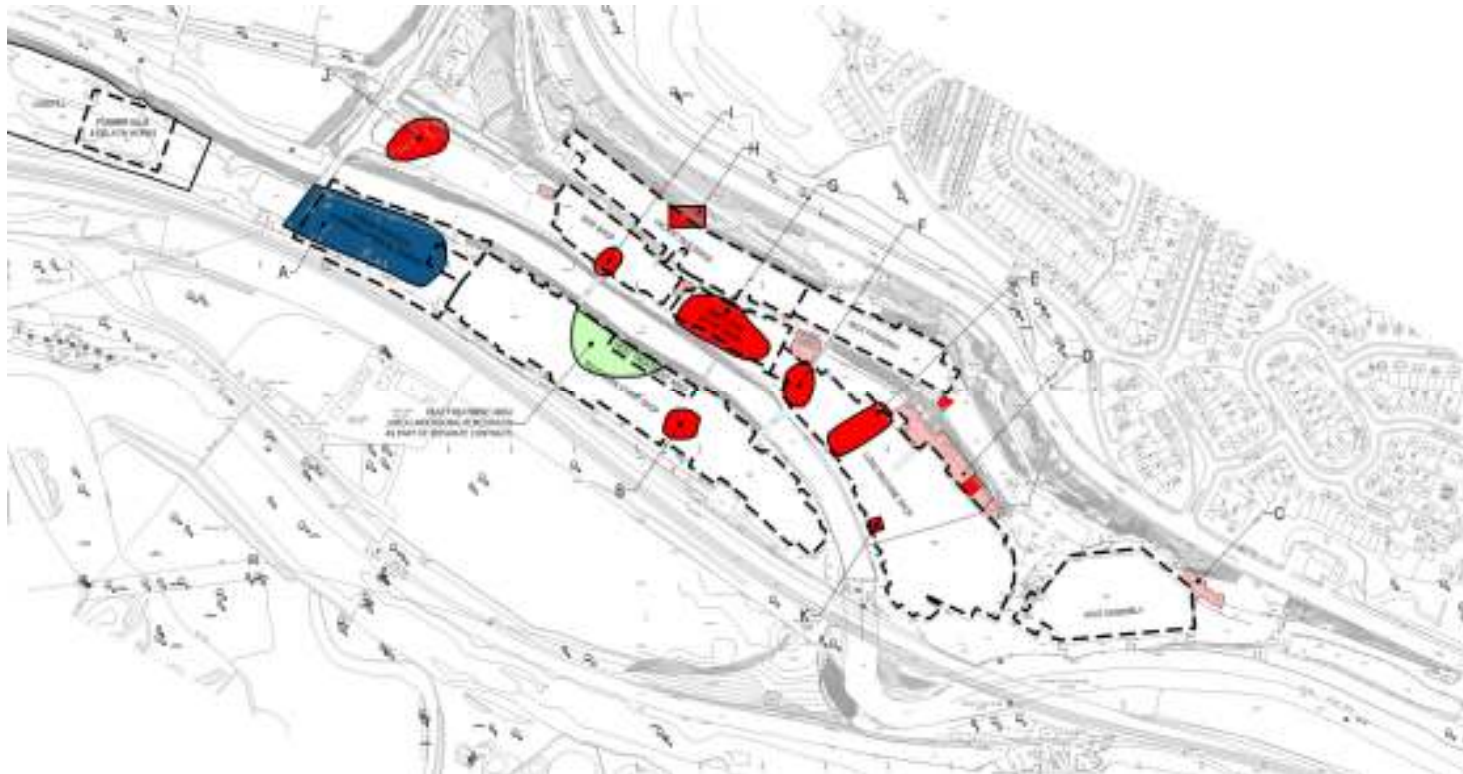
# Contamination

## Key Contaminants

- Diesel range hydrocarbons C10-28 – general former forge uses
- Coal tar – PAH – naphthalene and oil range hydrocarbons C20-35 – former chemical works
- Lubricating oils C20-C35– Heat Treatment Area

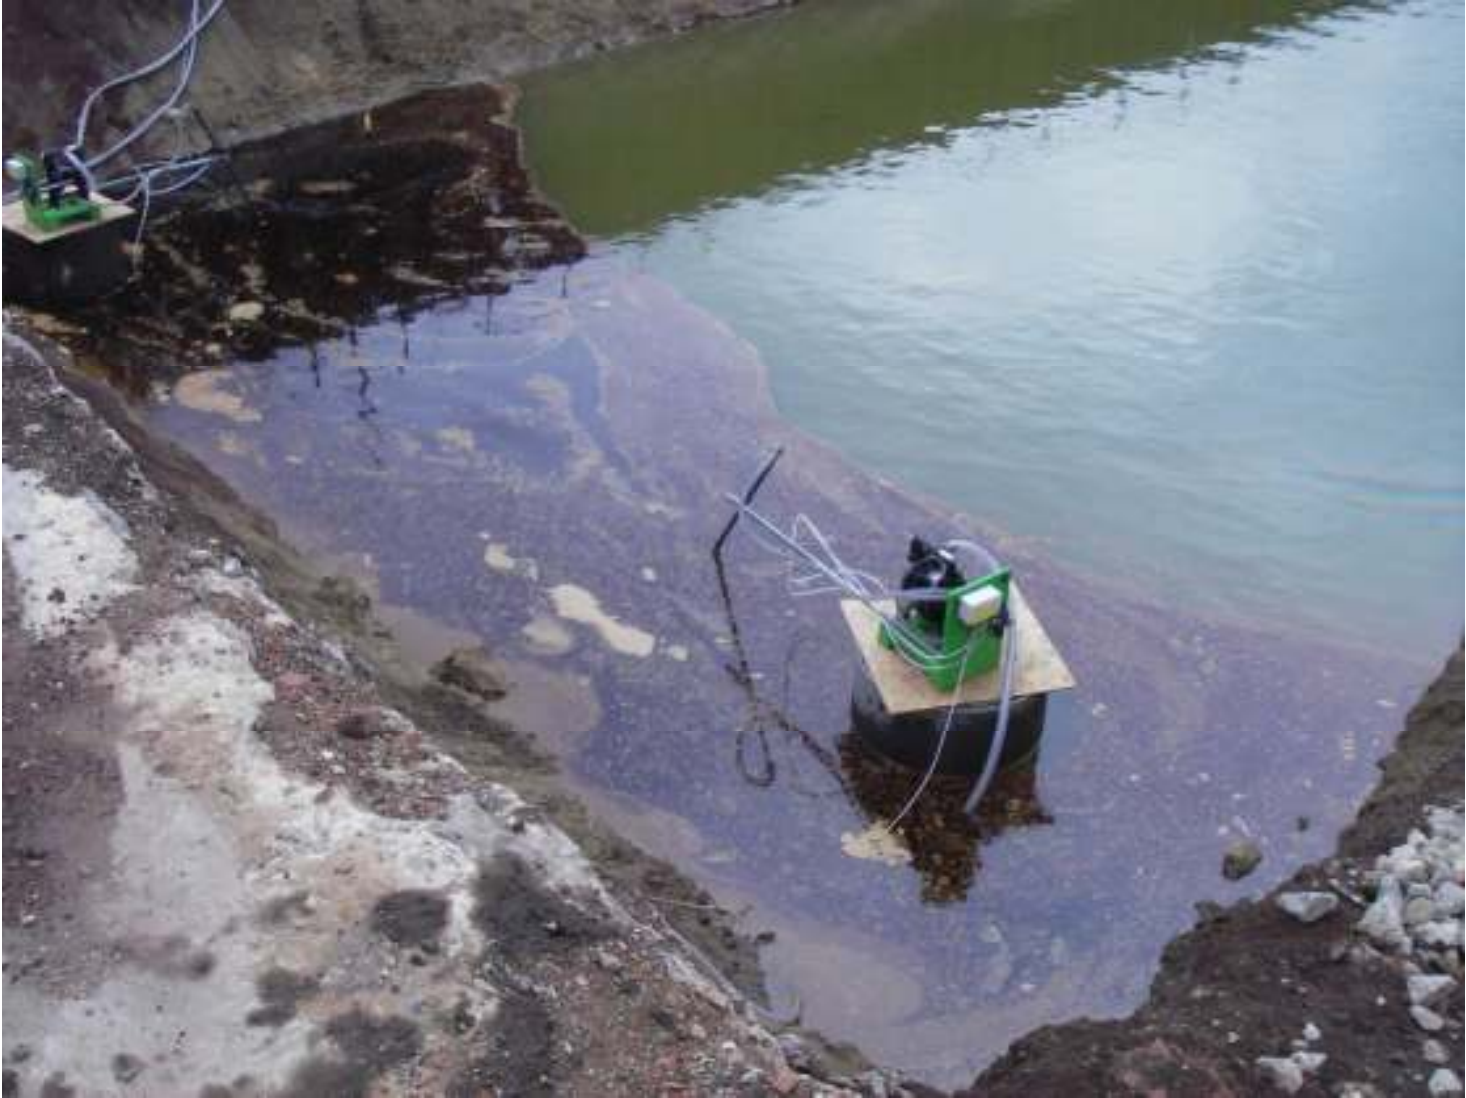
# Heat Treatment Area – LNAPL

- Worst area of contamination
- Former use – crane dipped heated metal into oil and then water prior to cooling on racks
- Included 3 oil quench tanks 52m<sup>3</sup> each
- Significant oil spillages – some near surface contamination
- Greatest contamination at groundwater level / smear zone
- Up to 0.8m free product LNAPL
- Remediated two phases 2002 and 2008 as early phase betterment

- First Phase Remediation
  - Free product recovery from boreholes – 1,400m<sup>3</sup> LNAPL removed
  - Residual LNAPL remained 0.1 to 0.4m thickness

- Second Phase Remediation
  - Excavation of clean overburden soils for re-use
  - Excavation of contaminated smear zone soils
  - Skimming of free product from water in excavation
  - Validation by visual inspection of groundwater – no visible free product
  - Limited off site disposal of most contaminated soils
  - Bioremediation of less contaminated soils for re-use

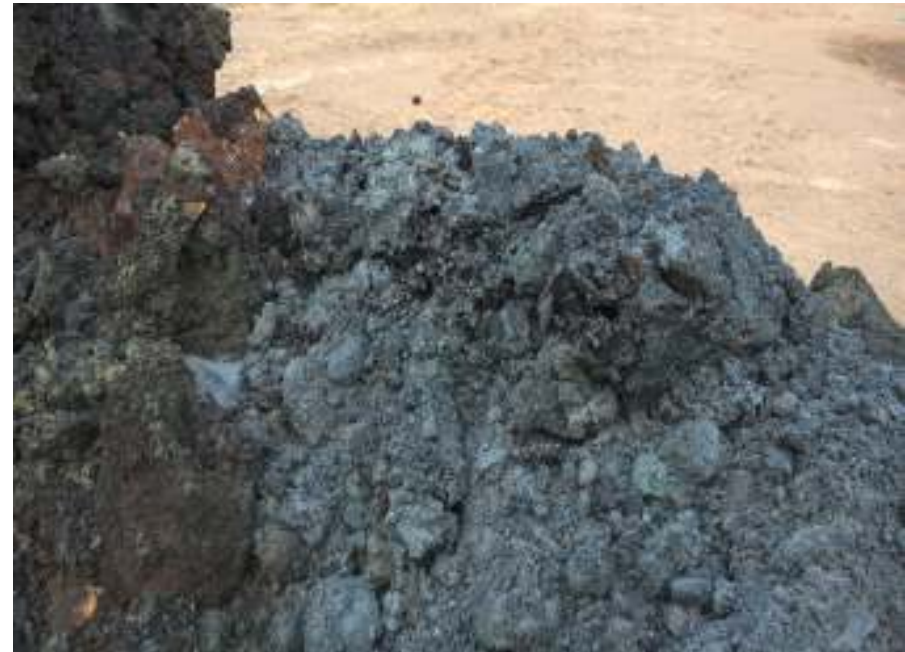
# Future Works

- Former chemical works area
  - approximately 10,000m<sup>3</sup> of soils - coal tar
  - likely stabilisation / solidification
  - re-use on site at locations not to be re-excavated

- Other areas of hydrocarbon contamination
  - mostly diesel range
  - likely treatable by bioremediation
