Innovative continuous odour monitoring during gasworks remediation

Advances in Contaminated Land Assessment and Remediation

University of Sheffield | 03 March 2023

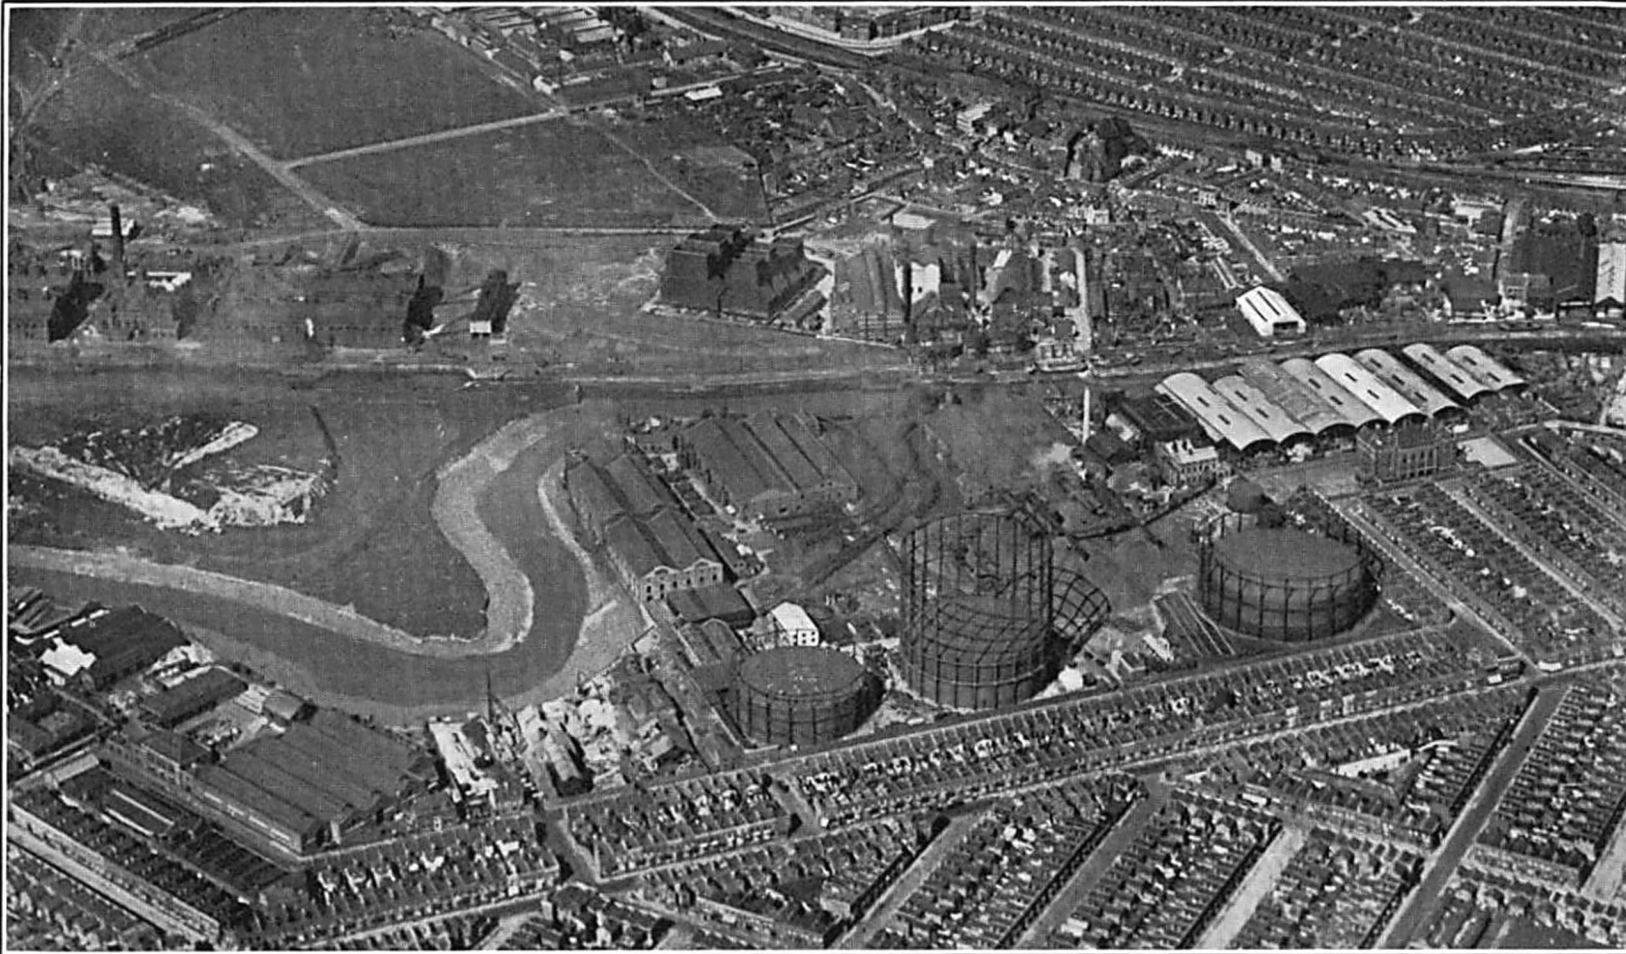
POPLAR WORKS—FROM THE AIR.

8.4 Ha site in East London.

Reclaimed land from 1804.

Former gasworks from late 1870s.

Legacy soil and groundwater contamination, incl.:

- tar
- foul lime
- spent oxide
- asbestos

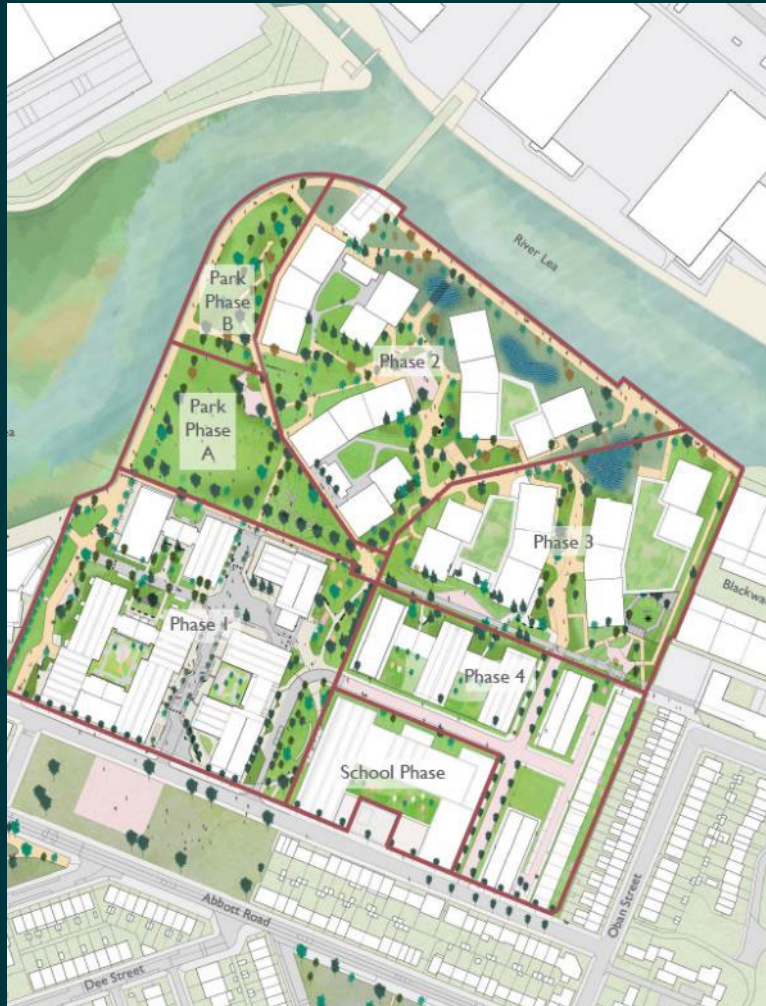
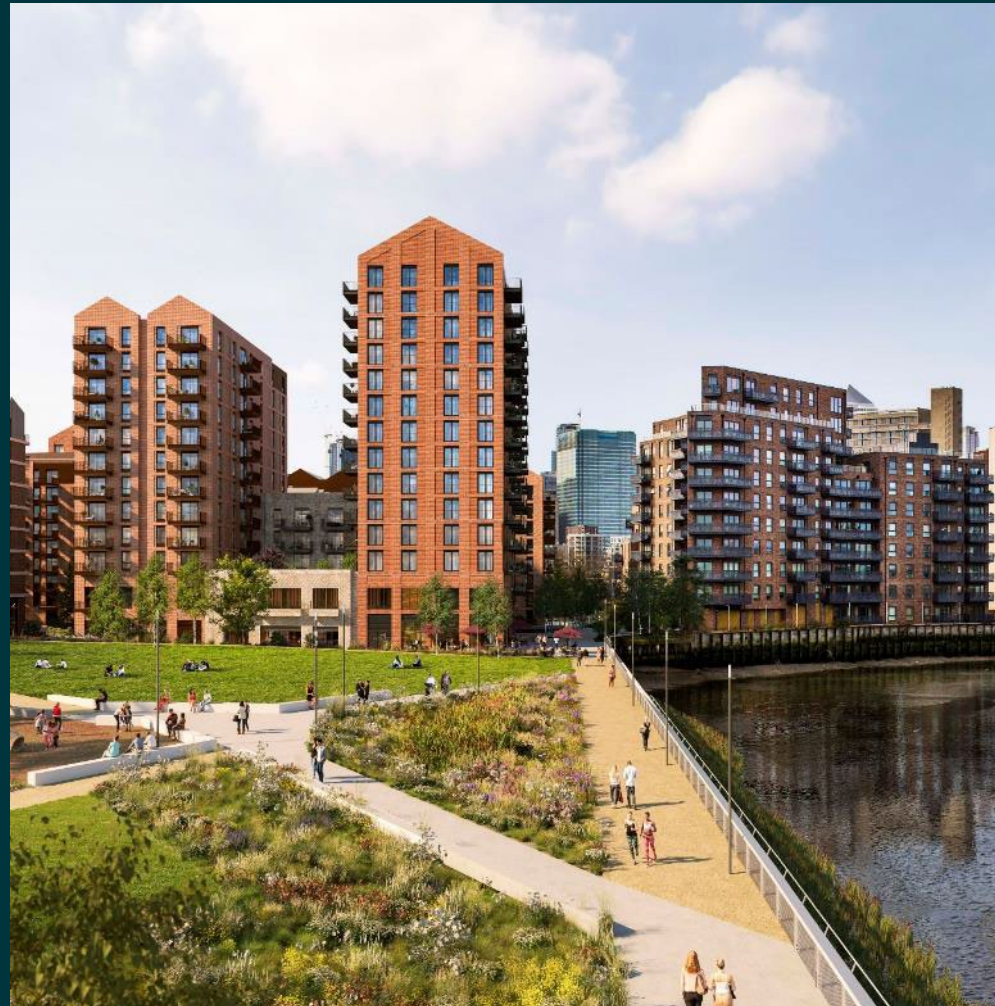
- Remediate entire site
- 2,800 residential dwellings
- 1 ha public park
- Retail / commercial space
- School
- Remediation ~14 months
- Construction ~20 years

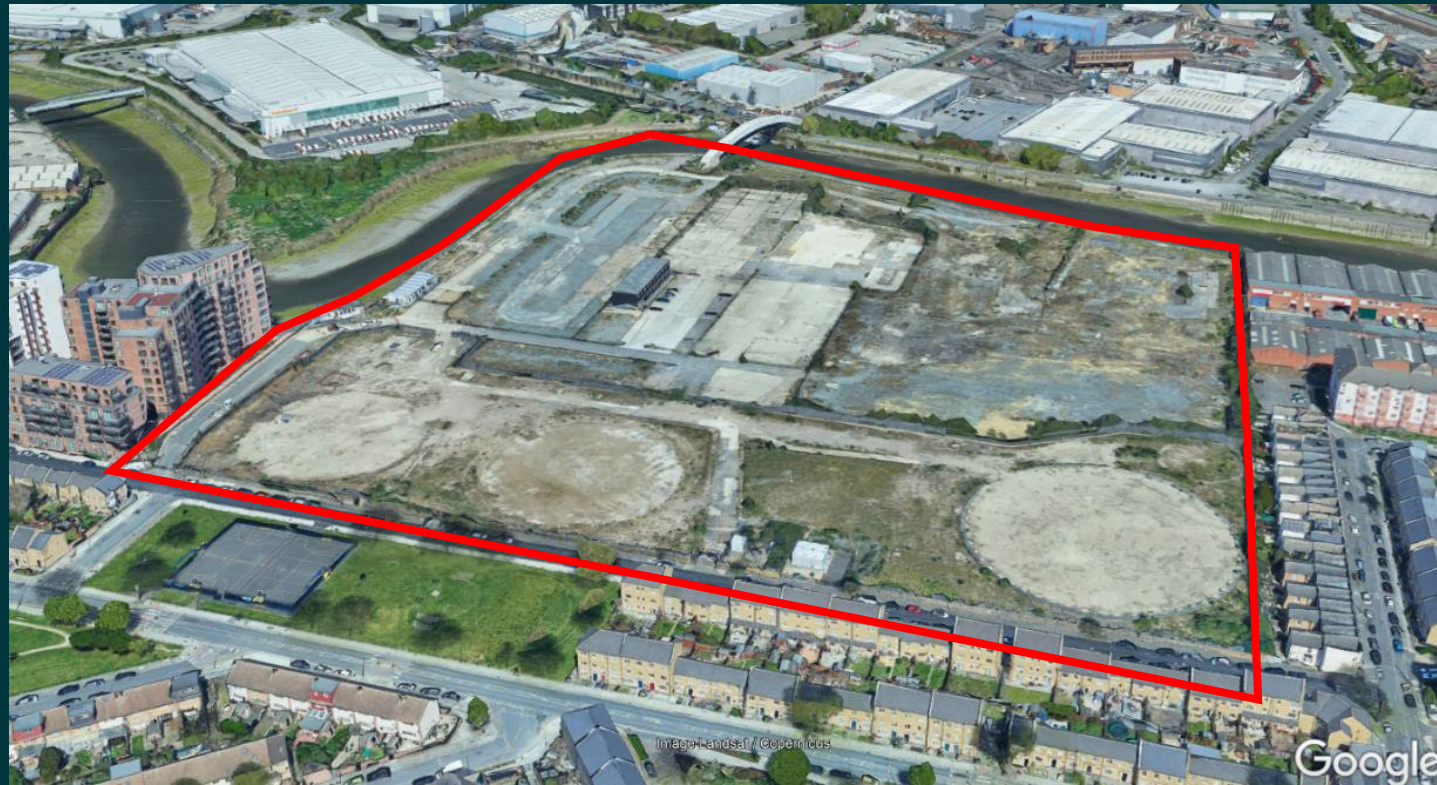
Residential dwellings on three site boundaries.

Regulator challenges / pressure.

Community scrutiny and some 'citizen science'.

COVID-19 pandemic and lockdowns.

Developer's desire for innovative practice.

Use of sub-surface gasholder as stabilisation work area.

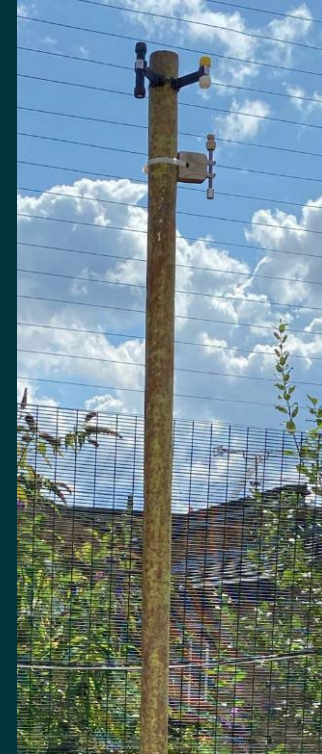
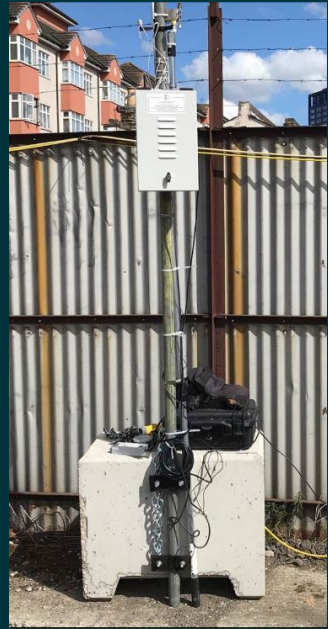
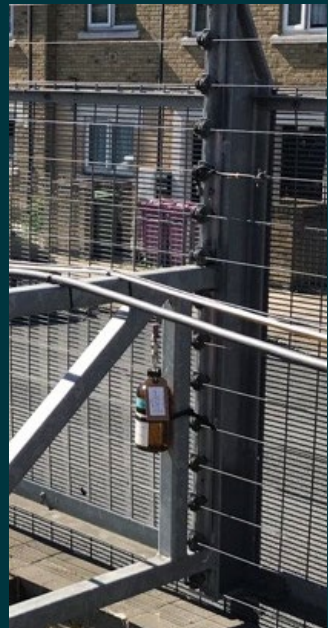
Two continuous dust monitors (reporting PM₁₀ and PM_{2.5})

Passive diffusion sampling for nitrogen dioxide (NO₂), hydrogen sulphide (H₂S), ammonia (NH₃) and volatile organic compounds (VOCs)

Short-term active sampling for VOCs

Audits with continuous logging photo-ionisation detector (detecting to ppb range)

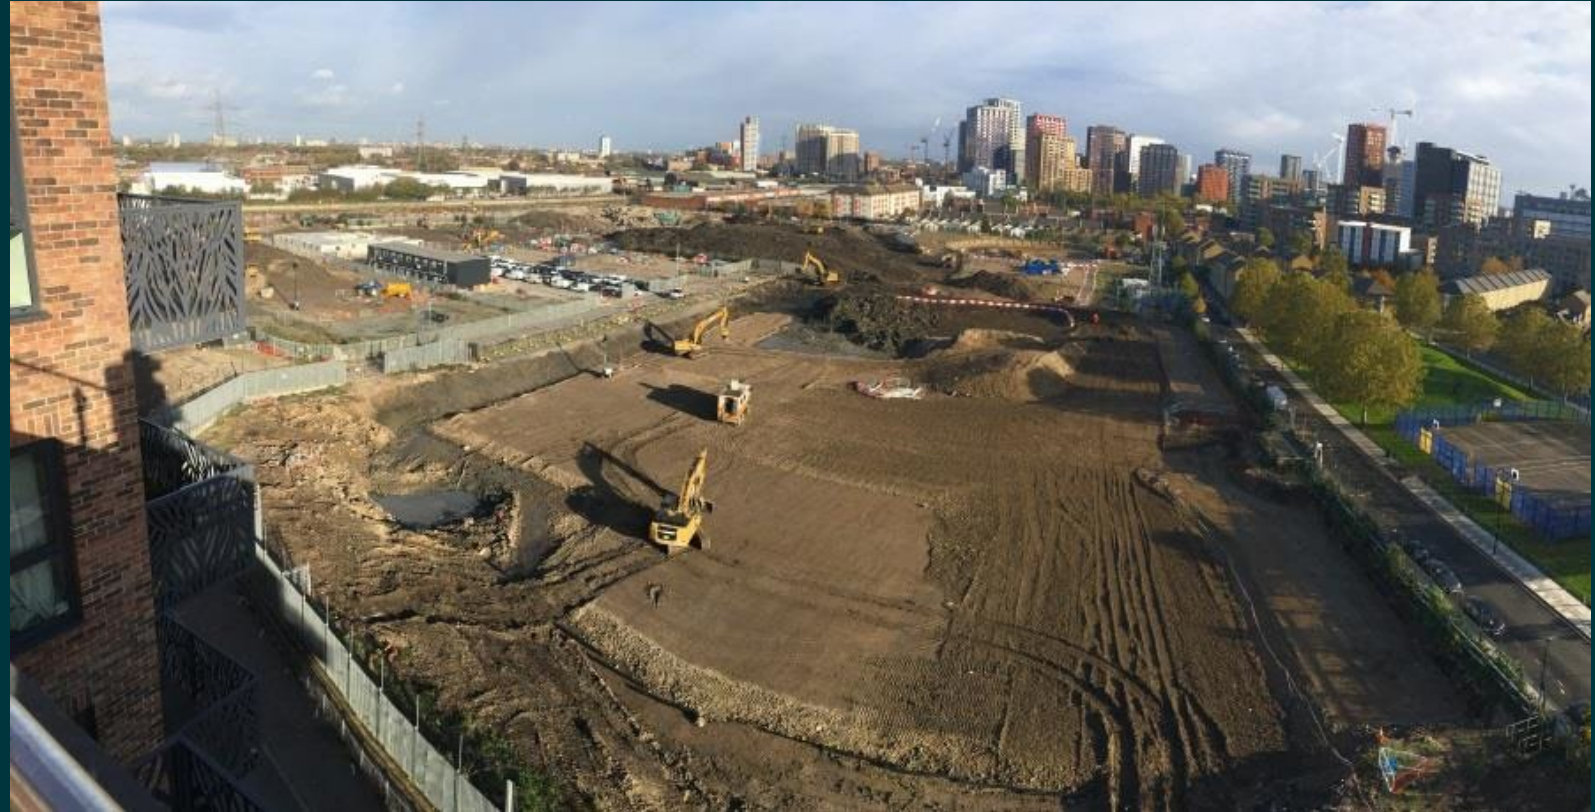
Developer challenge to evaluate additional techniques capable of continuous odour monitoring that could be deployed at the site

Literature review → capability for quantitative reporting of odour unit concentration (OU/m³)

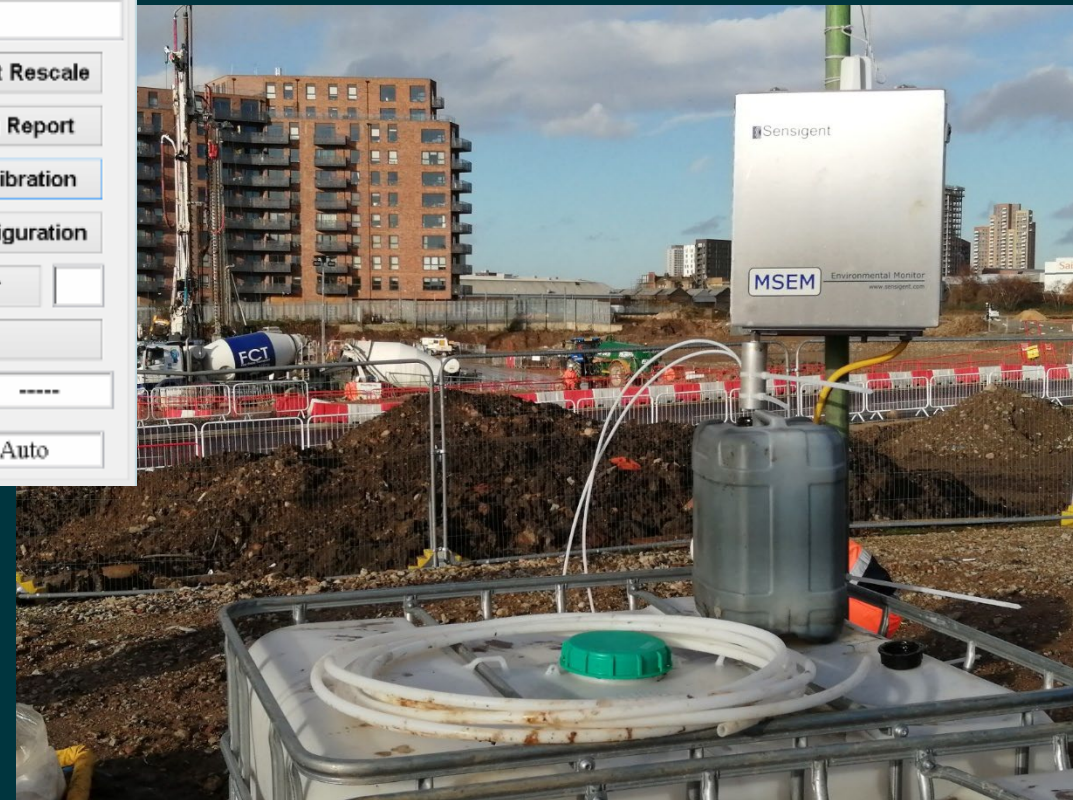
Zero
Calibration

Low
Range
Calibration

High
Range
Calibration

The screenshot displays the MSEM Control and Data Log Interface V6.00. The main window shows a table of current data and alarm thresholds for various pollutants. A dialog box titled "Enter Calibration Data" is open, allowing for the update of odor units and ID. The current data table is as follows:

Current Data	Alarm Threshold	Alarm Status
TVOC	0.0010 mg/m3	20	
H2S	0.0000 ppm	1	
NH3	0.0399		
SH	0.0000		
C2H4	0.1054		
ODOR UNITS	0.0000

The calibration dialog box contains the following fields:

- Update Odor Units:
- Update Odor ID:
- Data Date (MMDDYY): 121020
- Data Time (HHMMSS): 124438
- Odor Value (0-2000): 304
- Odor ID class (1-5):
- Log Data Present?: Yes
- Delta Time (seconds): 0

At the bottom of the interface, the status bar shows: Current Date/Time: 02/05/21 18:14:59, Comm Status: 100%, Filter Status: NO FAULT, Mode: Auto.

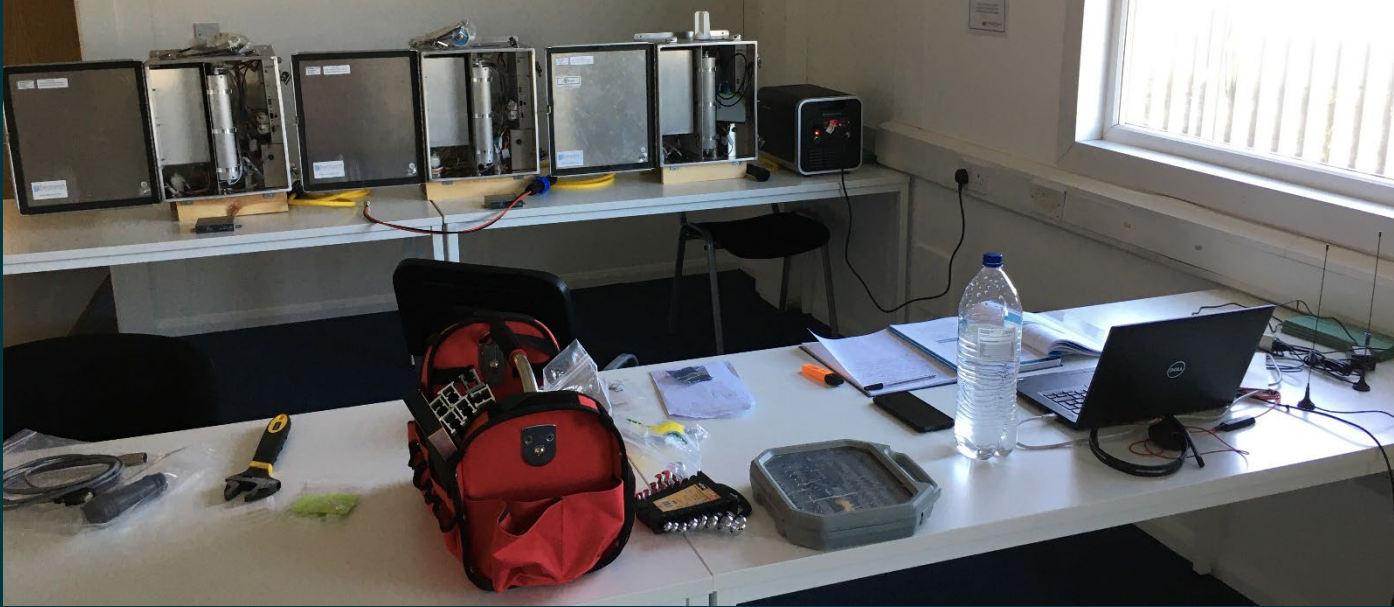
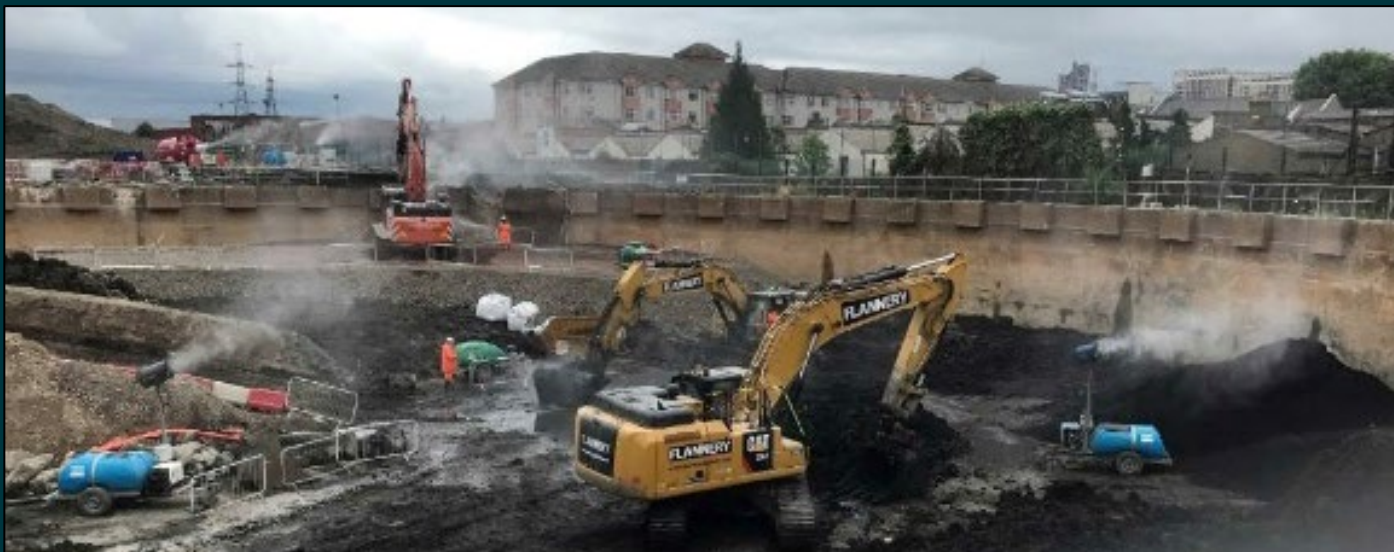
New / innovative solutions can come with teething problems

- DIY (instruments, connections, mounting)
- User friendliness of interface
- Flexibility of data handling/processing
- Alert communications limitations
- Portable doesn't necessarily mean portable!
- Tech support time difference
- Service and manufacturer calibrations

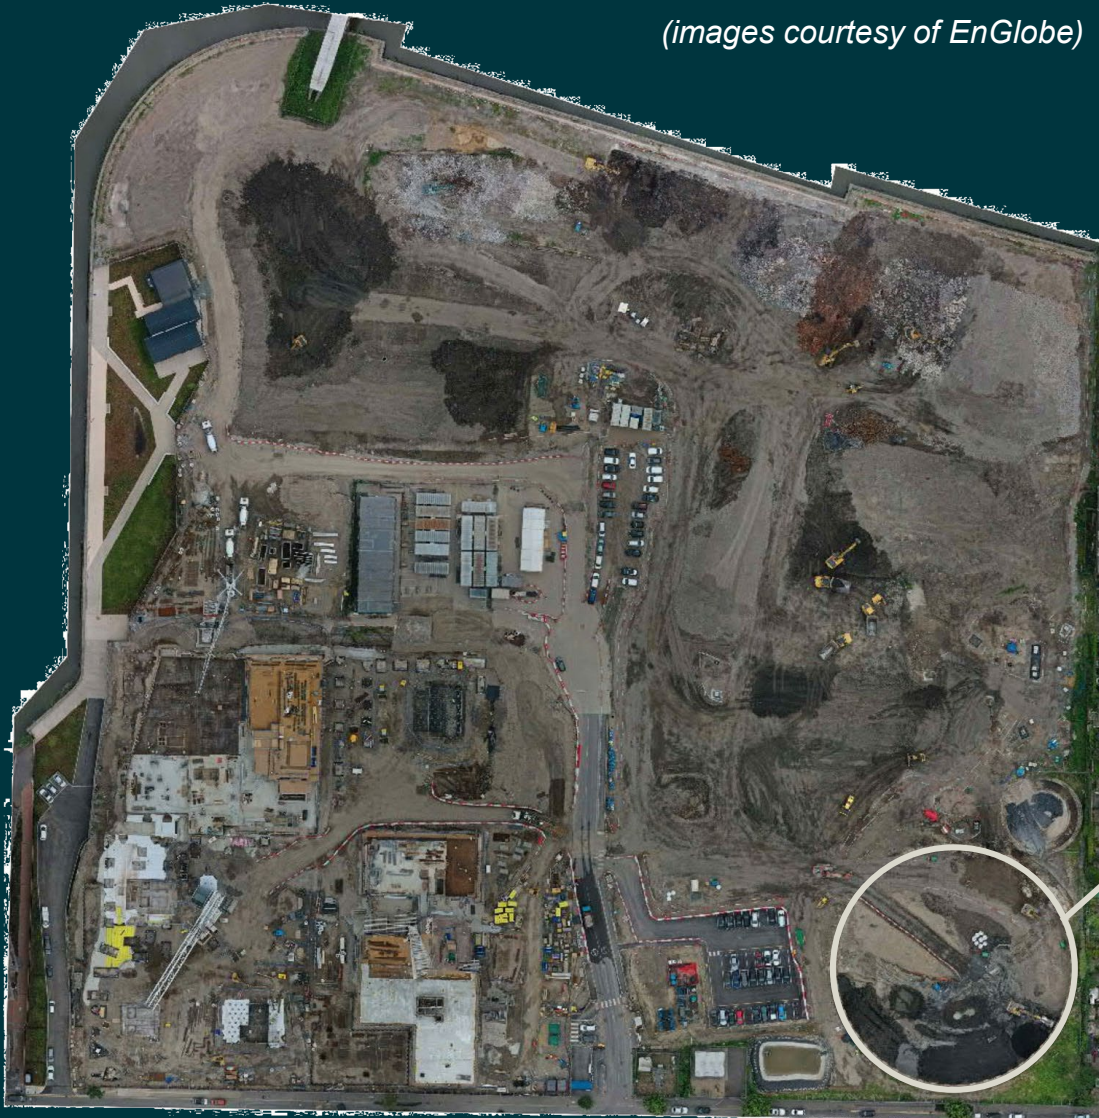
Effectiveness of using gasholder as 'container' to control odours

Odour monitor interferences
